Advanced firmware update

A new feature available in the advanced service menu allows firmware to be replaced by any firmware from within the series. (E.g. Uploading MAC Viper Wash firmware to a mainboard loaded with MAC Viper Profile firmware)

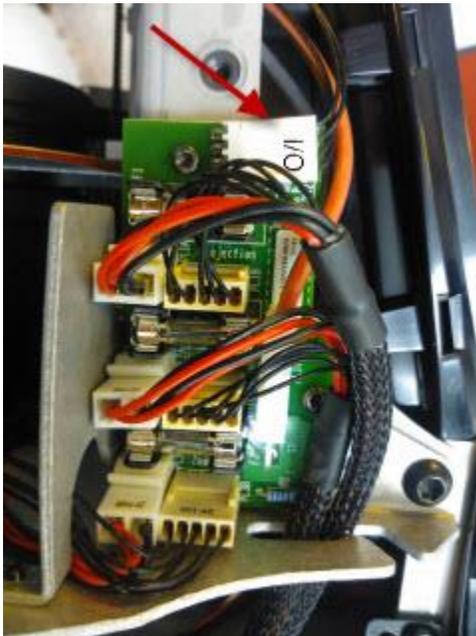
Head:

When swapping the 62050019 *PCBA*, 3318 *CPU Board* with a CPU board that has different firmware, it is crucial that the service technician disconnect the *I/O* wire between the mainboard and the rest of the product before applying power to the product.

If this is not done, the adjustment and calibration settings will be overwritten.

Disconnecting the I/O wire

The I/O wire can be disconnected in either the head or the base.
