Why is my firmware transfer failing?

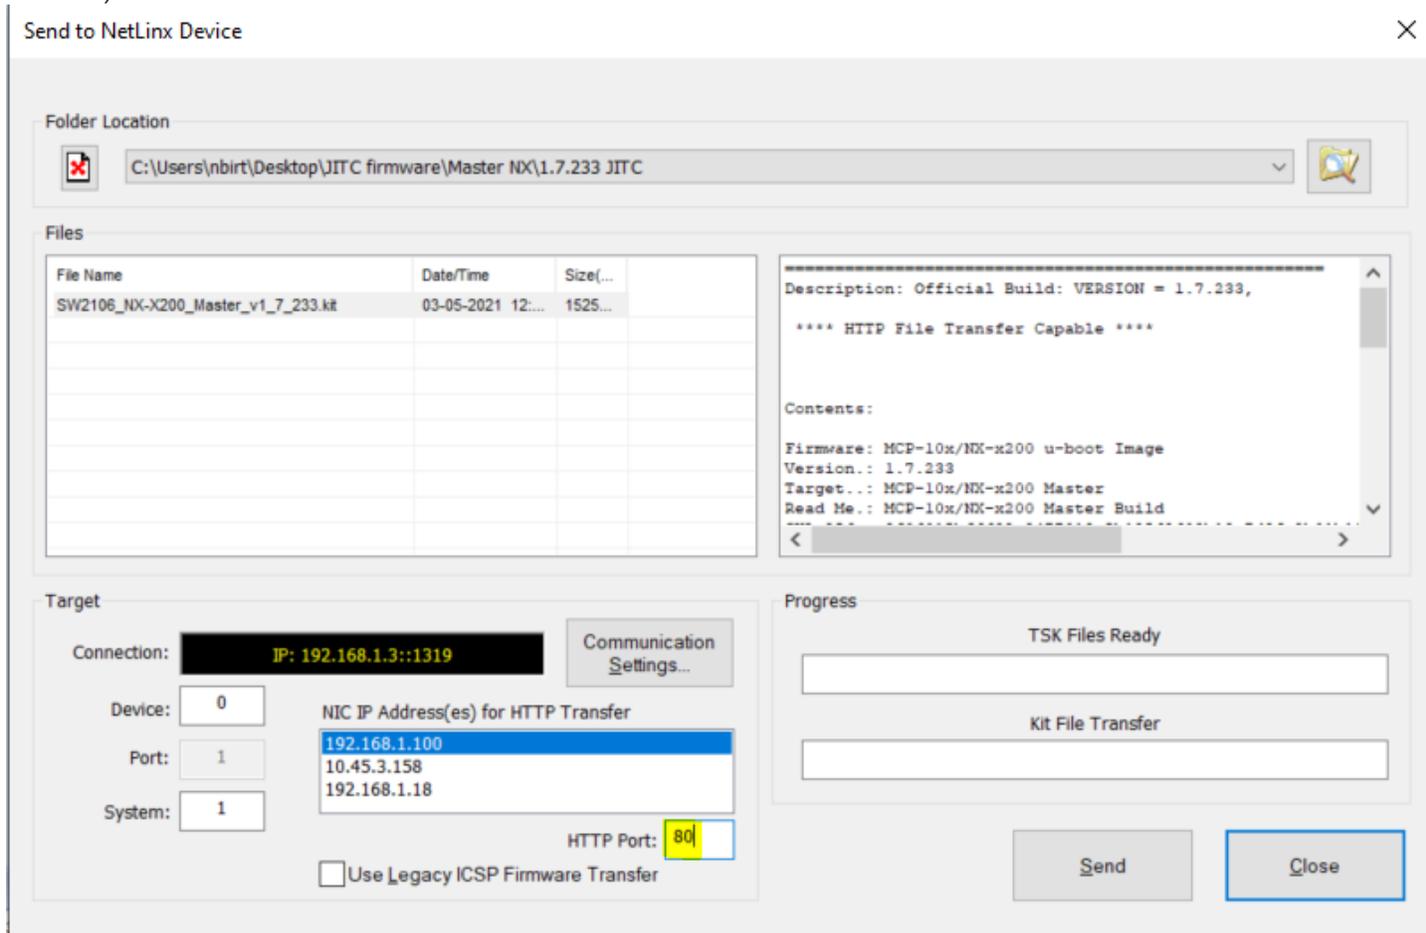
- Network or Windows firewall blocking inbound port 80 connection from Netlinx Controller to the PC. To resolve this issue, temporarily disable your Windows Firewall, or configure Windows Firewall to allow Netlinx Studio through the firewall. If the firewall is on the network, work with your network administrator to allow for the required inbound port 80 connection to Netlinx Studio. If these measures do not allow the firmware update to succeed, the final option is to change the port number for HTTP transfer from port 80 to an unused port number. Often port 81 works when port 80 doesn't. (Refer to image below to see where to change the port

- Your PC may have multiple IP addresses and you have selected an address that is not in the same network range as your Netlinx Controller. To resolve this, verify what network range your Netlinx Controller is in and select the IP address in Netlinx Studio that matches that range. (Reference the image above)

number.)
